8 MARCH 2024

**PRELIMINARY REPORT ON EXPRESSWAY DAMAGE:
TWO MONTHS SINCE THE 2024 NOTO PENINSULA EARTHQUAKE**

CHAKRABORTY ANIRBAN • HOSEI UNIVERSITY
HISAKAZU SAKAI • HOSEI UNIVESITY

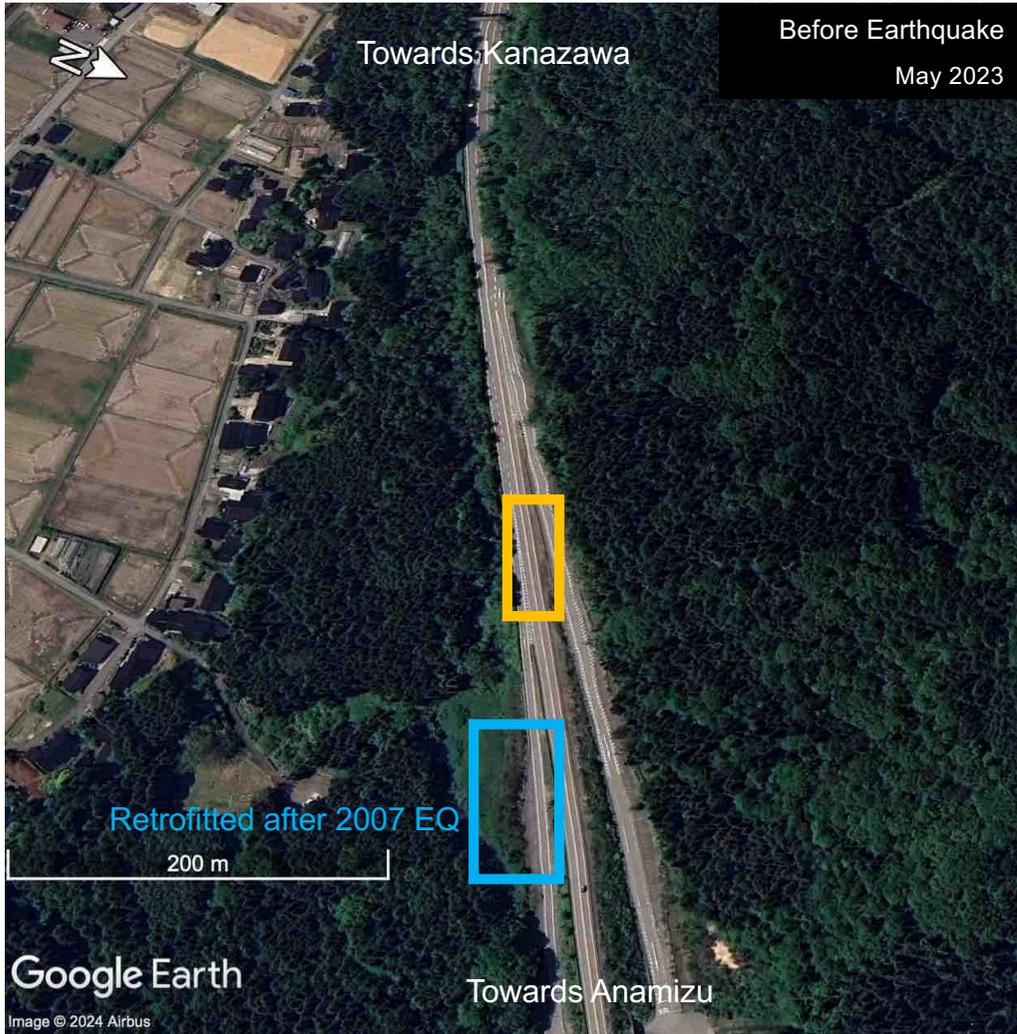
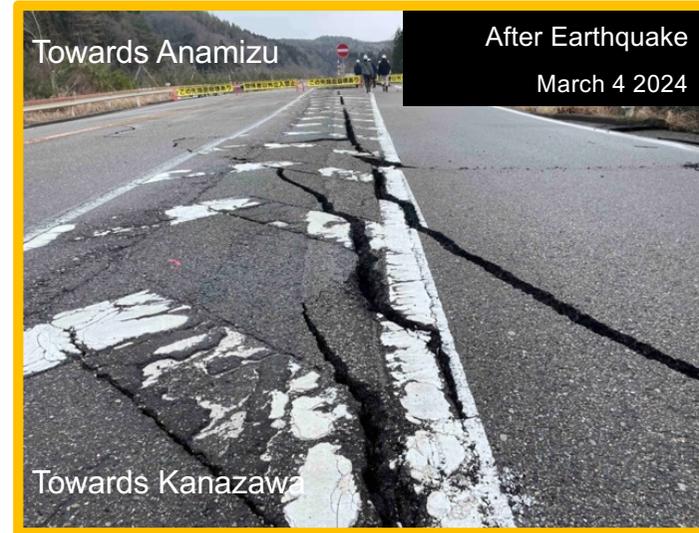
LOCATION 2

Large cracks were seen on the road surface in the yellow zone. There was no evidence of the embankment collapse.

The blue zone marks an area that was restored after the 2007 Noto peninsula earthquake (EQ). No damage was seen here during this 2024 earthquake.

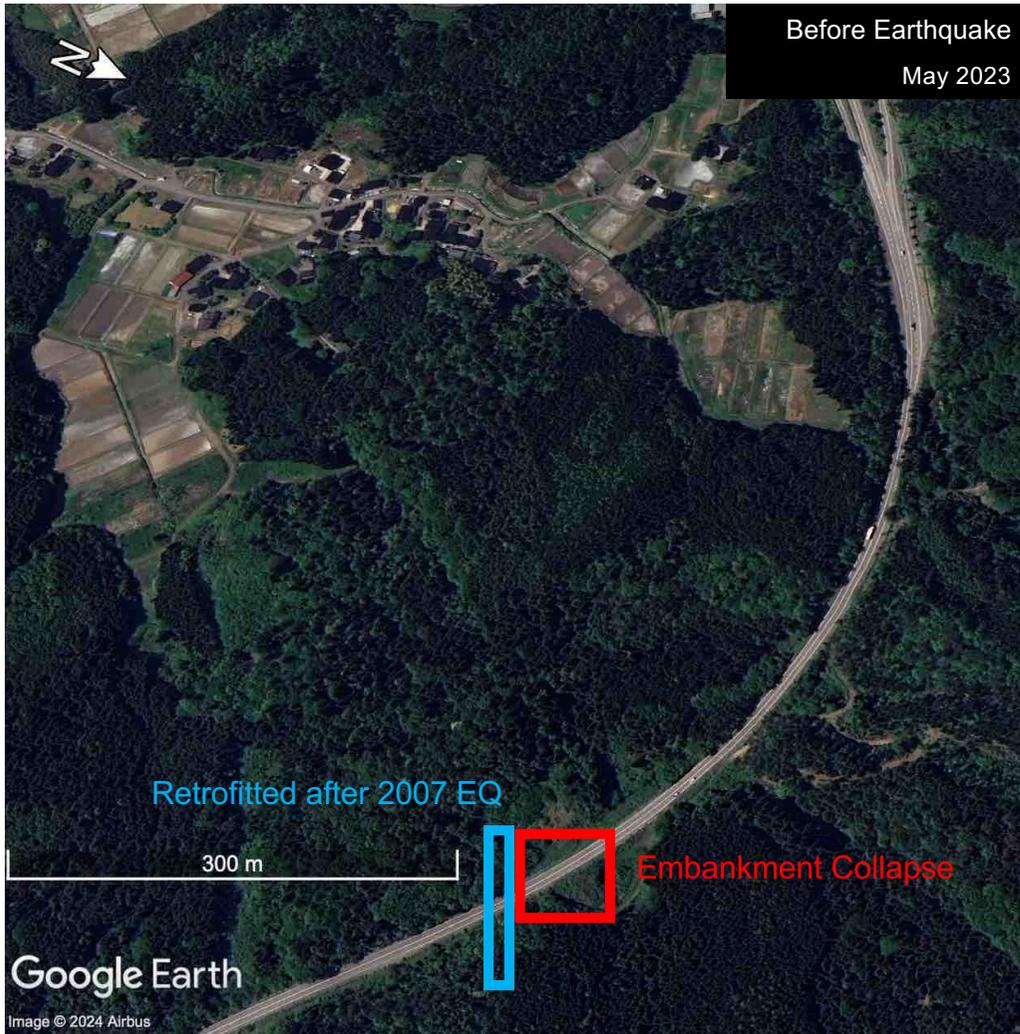
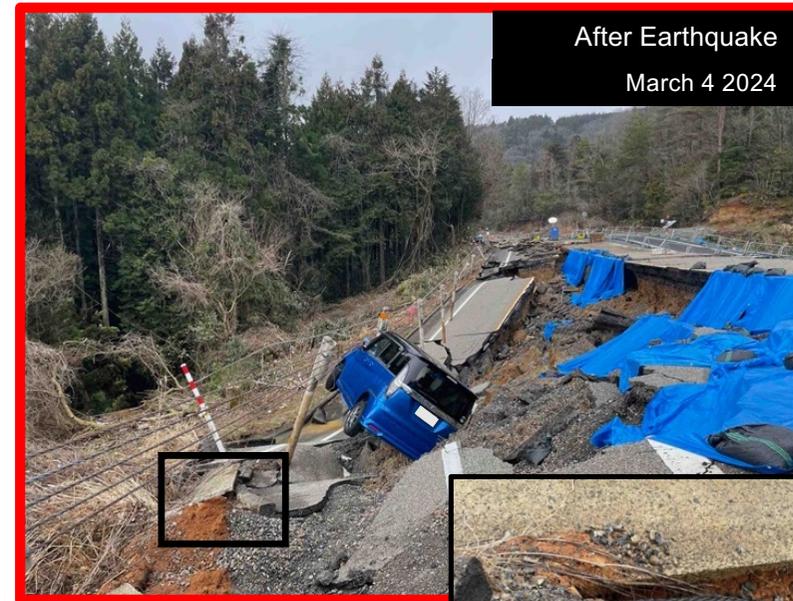
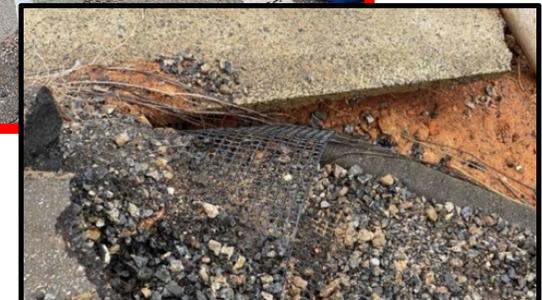
LOCATION 4

Exposed geotextile from after 2007 EQ retrofit

Collapse of the embankment was observed. However, the collapse area shares border with an area retrofitted with geotextiles after the 2007 Noto peninsula earthquake. The retrofitted area withstood the 2024 Noto peninsula earthquake, thus, limiting the extent of the collapse and preventing a large-scale disaster.

- The embankments retrofitted after the 2007 Noto peninsula earthquake withstood the strong ground motions of the 2024 Noto peninsula earthquake. No significant damage was observed. In the case of Location 4, the retrofitted embankment helped check the continuation of collapse and prevented a large-scale disaster.
- The importance of proper drainage in road embankments was recognized. In the Noetsu Expressway, the well-drained embankment withstood the strong ground shaking.
- The good performance of geotextiles as a retrofitting material was also observed.

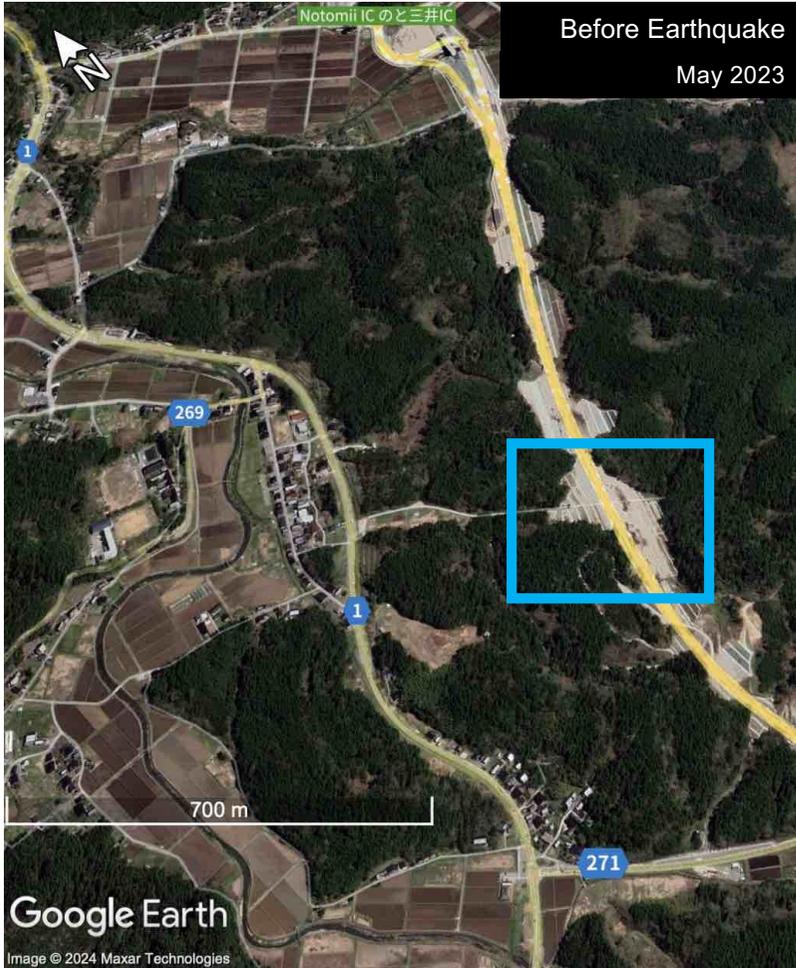
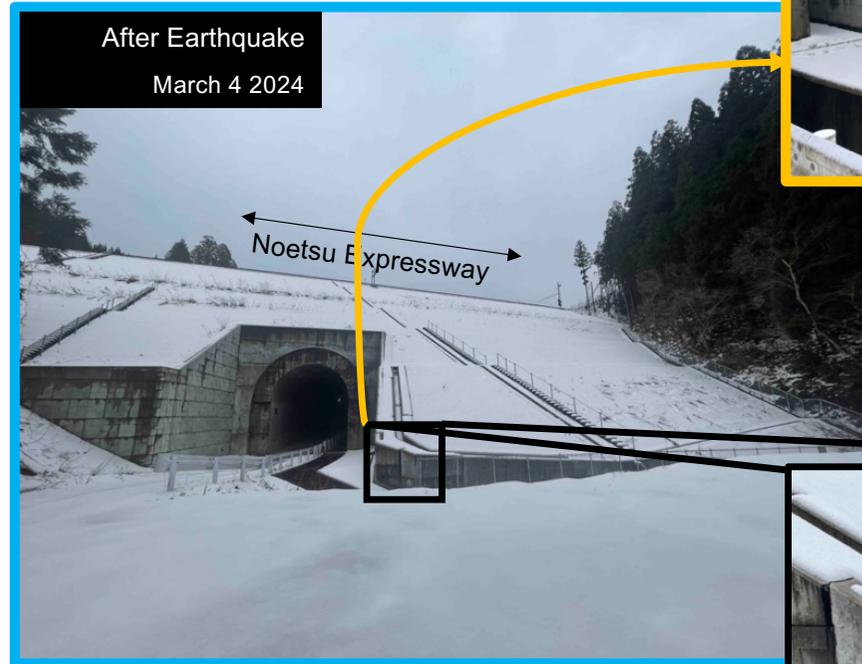
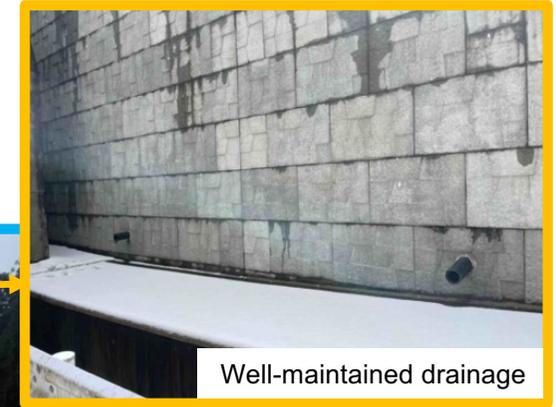
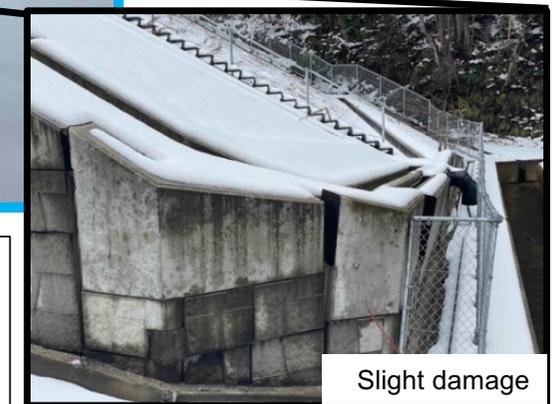
LOCATION 5

No collapse or major damage was observed in this embankment. Well-maintained drainage possibly helped in quick dissipation of excess pore water pressure created during excessive shaking.

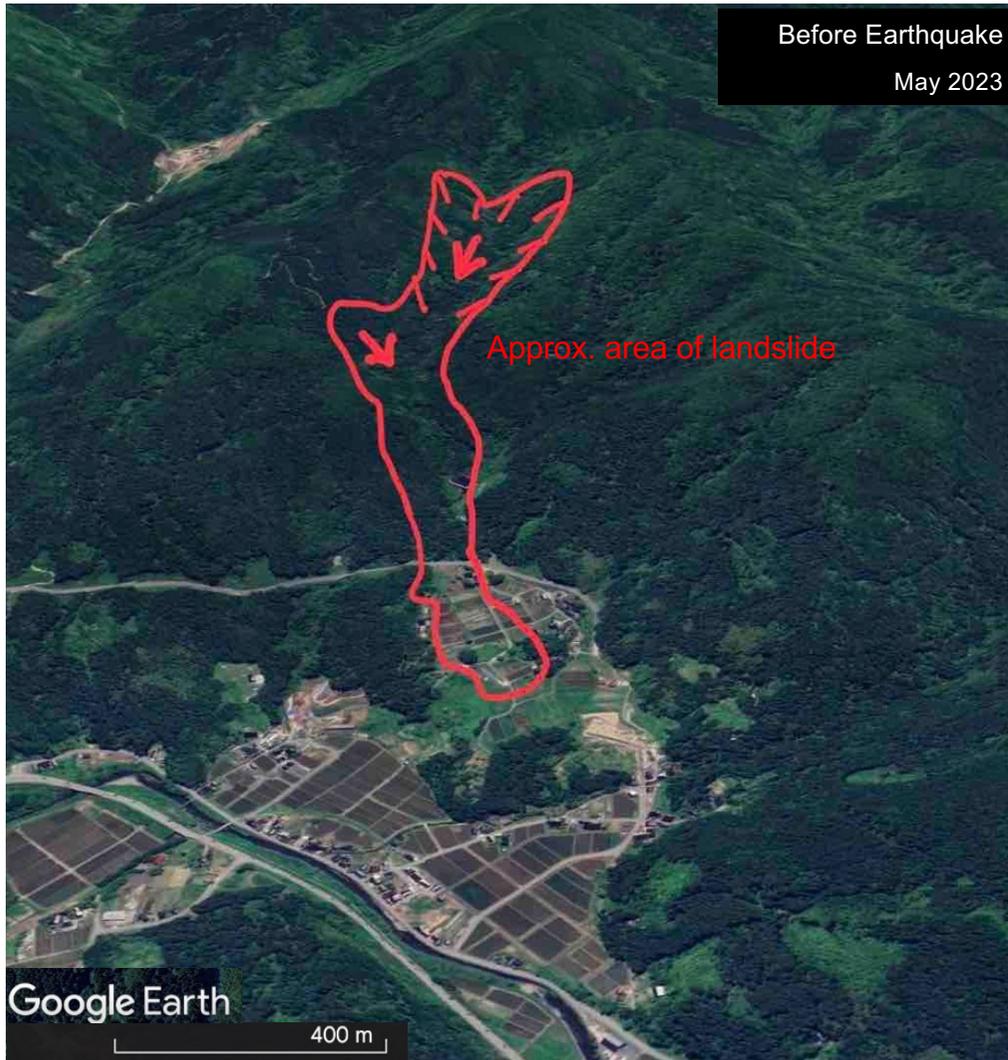
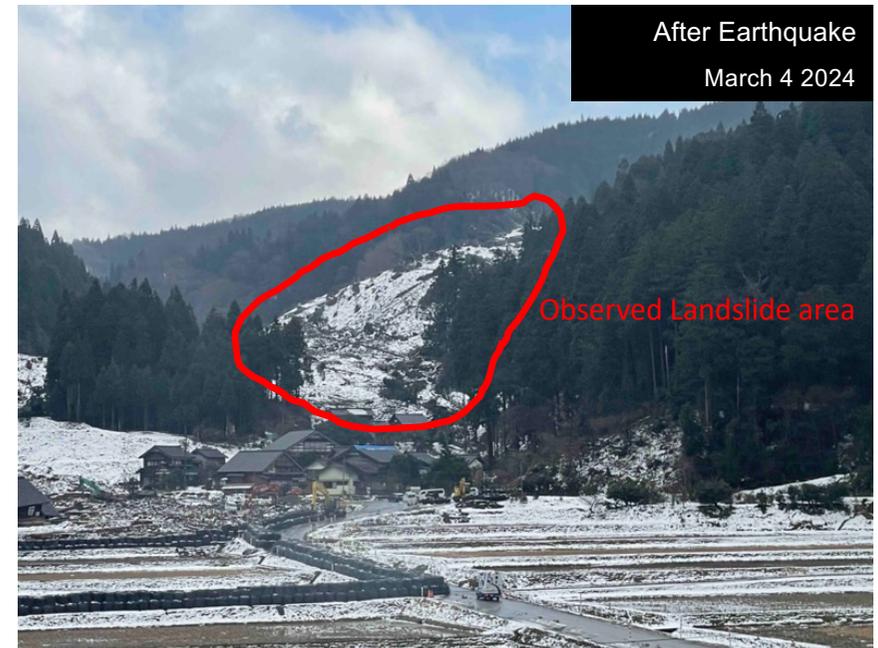
LOCATION 6

Due to ongoing relief and restoration work, it was not possible to inspect the site up close.
